Manhole Inspection Summary

Manhole # S53K__037MH

Insp Date: **3/7/08 3:38 PM**

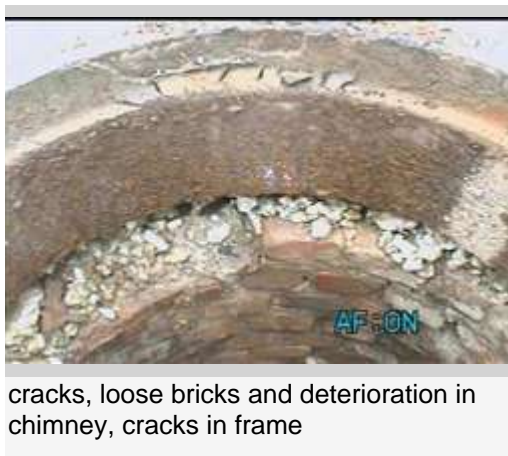
Defect 2

Frame Offset: **0** (in.) Condition: ☐ Sound ☒ **Cracked** ☐ Leaks

Condition: ☐ Sound ☒ **Cracked** ☐ Root Intrusion ☒ **Loose Brick** ☒ **Deteriorated**

cracks, loose bricks and deterioration in chimney, cracks in frame

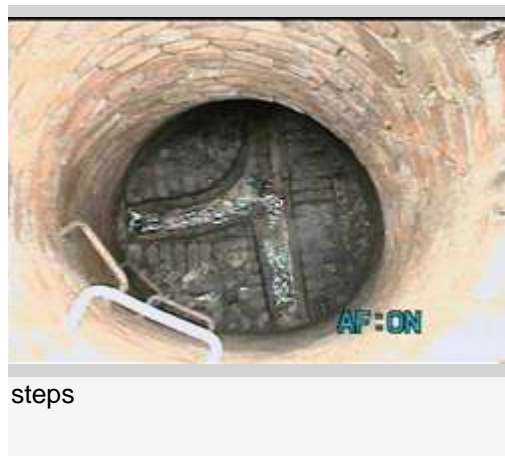
Defect 1

Steps Count: **4** Missing: **0** ☒ **Corroded**

steps

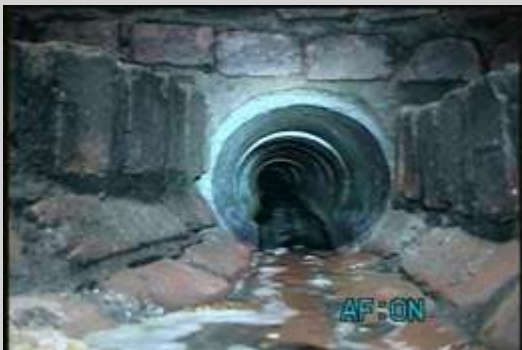
12 O'Clock Outflow

8 in. Circular Gravity Sewer
Pipe Out @ 12 O'Clock

Invert Depth: **10.40** (ft.) Flow Characteristics: **Slow**

Infiltration: **None** Pipe Seal Cond: **Unknown**

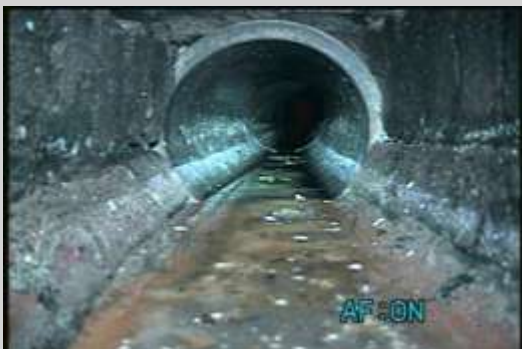
6 O'Clock Inflow

8 in. Circular Gravity Sewer
Pipe In @ 6 O'Clock

Invert Depth: **10.10** (ft.) Flow Characteristics: **Slow**

Infiltration: **None** Pipe Seal Cond: **Unknown**

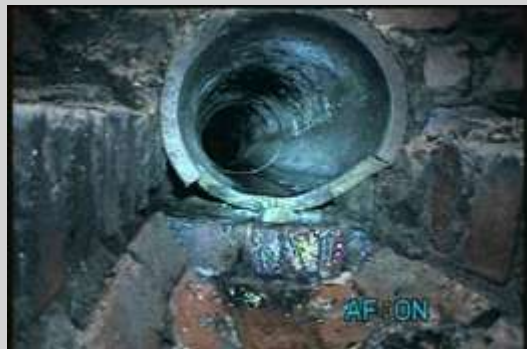
9 O'Clock Inflow

8 in. Circular Gravity Sewer
Pipe In @ 9 O'Clock

Invert Depth: **10.10** (ft.) Flow Characteristics: **Slow**

Infiltration: **None** Pipe Seal Cond: **Unknown**
